# R.M. COCHRAN COMPANY, INC. Newsletter - November 2012

### HARLOW PROPERTIES

### **ROXBURY CORNERS** .....

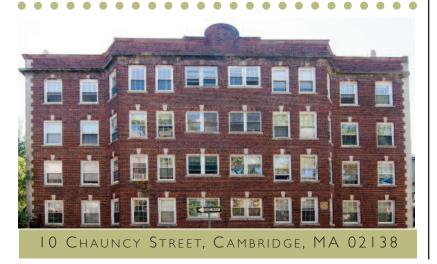
The client hired RM Cochran to repair some of the corbeled stone located around the inside courtyard.

Though the outside temperature was dropping, the use of a high strength polymer that sets quickly, allowed our staff to re-form the ledges over the

newly installed rebar, just in time.

The tight, inner courtyard required the use of a Teupen lift which was ideal for this job because of its small footprint, light weight and maneuverability.

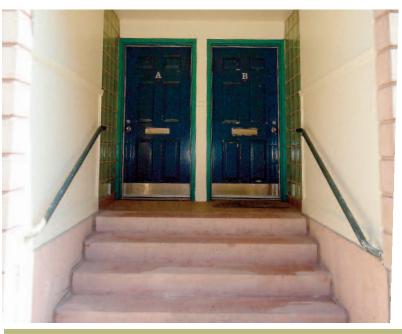
1782 WASHINGTON STREET, BOSTON, MA 02118

Our client needed nine front entrances renovated. The entrances were updated with ½" composite thermoplastic wall board, baseboard and chair rail. Sealants were applied to make it weather tight and exterior latex paint finished the job.
